AVIATION INVESTIGATION REPORT

A03H0001

COMMUNICATIONS FAILURE AND LOSS OF SEPARATION

NAV CANADA

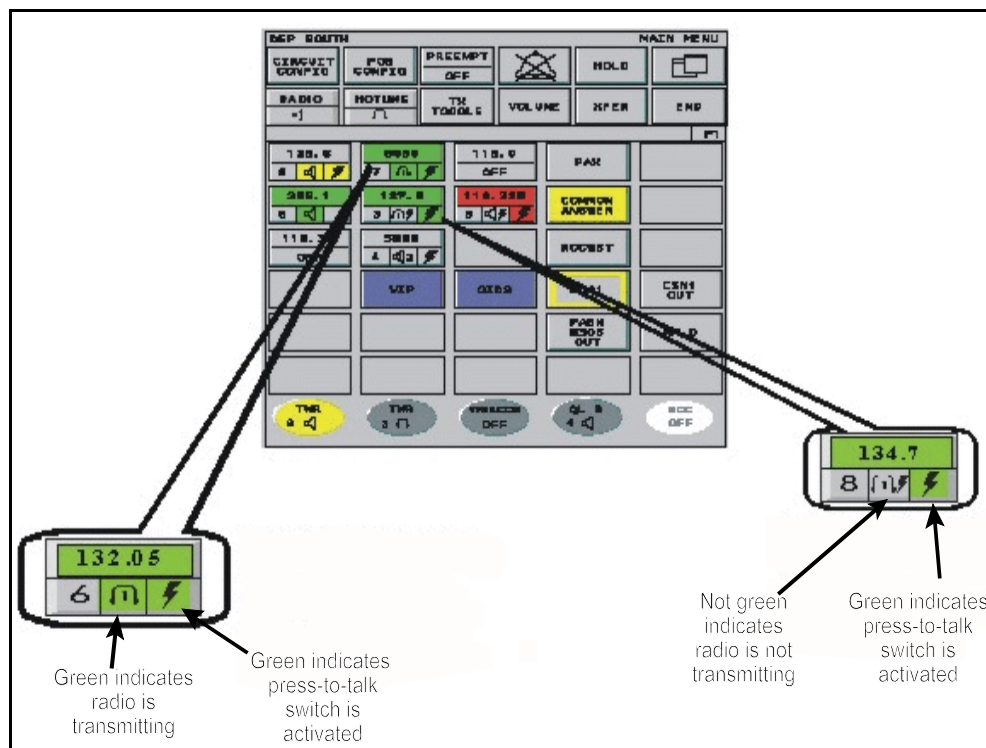
Figure 1. Voice switch communications system communications display panel

The VSCS is the primary interface for controllers to access the radios and landlines. The VSCS CCP is a display module (see Figure 1) located at each control position. The CCP is a touch sensitive screen which displays all the air/ground frequencies and landlines available to controllers. Each frequency is displayed separately on the screen by a rectangular icon. Different sections of the frequency icon show green depending on what the controller is doing: receiving, transmitting or has pressed the 'press to talk' switch but no transmission occurs (this indicates that there is a fault).

The VSCS training provided to controllers included both classroom instruction and hands-on practice. The controller involved in this incident was not aware that the specific green pattern in the frequency icon for 134.7 MHz indicated that he was not actually transmitting on that frequency, even though he had depressed the 'press-to-talk' switch. This was the only direct indication to the controller that there was an air traffic control (ATC) communications equipment failure. During the investigation it was determined that some other controllers were also not aware of the significance of the various green light indications on the CCP.

The VSCS CCP display provided one clue that the loss of communications was caused by a failure in the ATC communications system and not by the aircraft; however, the differences in the display indications on the VSCS CCP was not obvious to the controller. A glance at the frequency icon would have shown what the controller expected to see whenever he attempted to activate the frequency, that is, an overall green indication. However, only a close look and detailed familiarity with the meaning of the different types of display patterns on the frequency icon would have alerted the controller that he was not getting out on the frequency. Although the controller had received instruction on the operation of the VSCS during training, and had used this equipment for a number of months, he was not aware of the variety of display patterns nor of their exact meaning. The controller involved in the incident was not alone in not knowing the meaning of the presentation on the VSCS CCP frequency icon. The supervisor, on looking at the VSCS CPP, did recognize that the controller was not transmitting on 134.7 MHz.

It was not common knowledge among technicians and controllers that an anomaly in the communications control panel (CCP) of the voice switch communication system (VSCS) existed that allowed a green transmitter light on the CCP to indicate that the transmitter has been keyed and should be transmitting when in fact it was not. This deficiency has been identified to NAV CANADA's Operational System Requirements Branch for resolution.

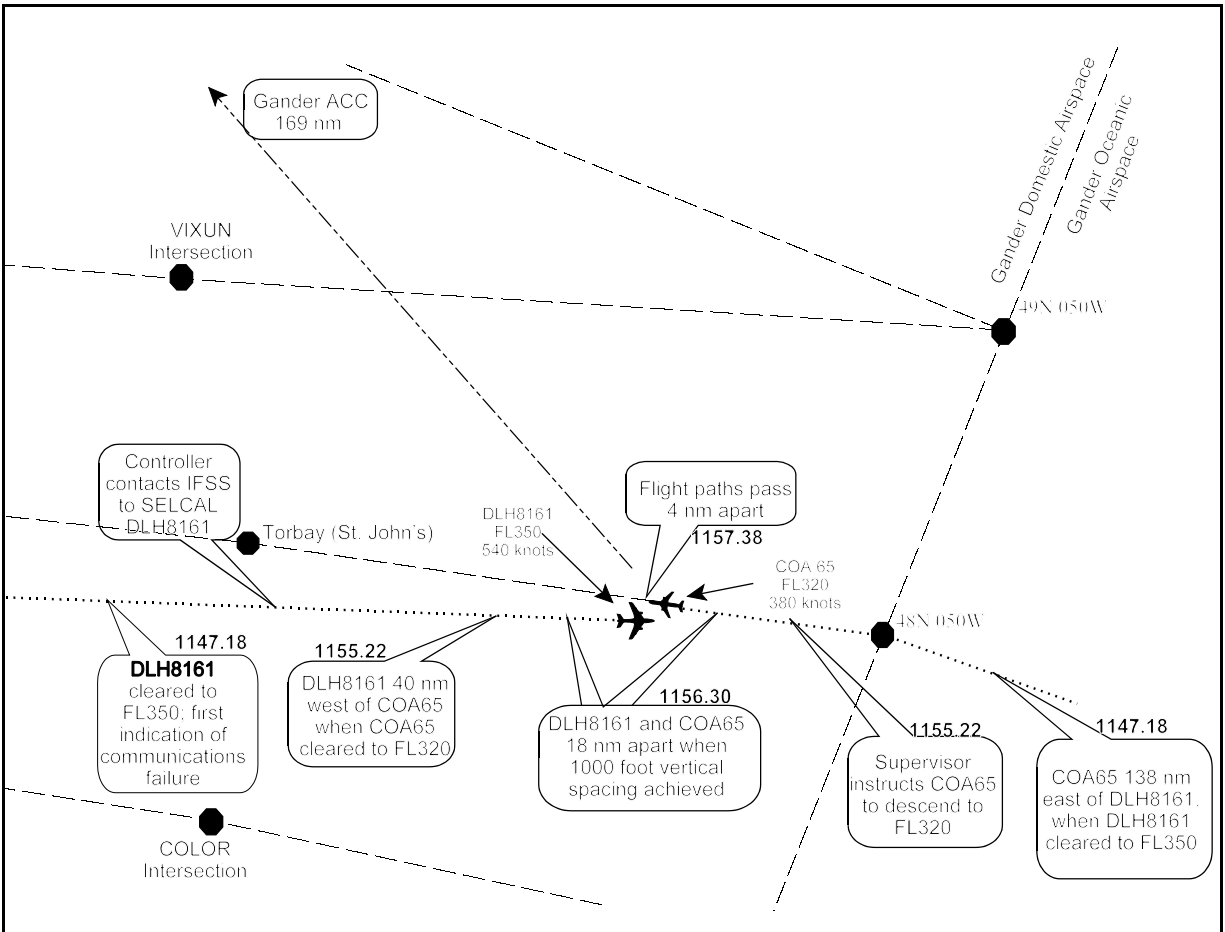
Appendix A - Sequence of Events

At 1147, in order to establish vertical separation between the aircraft, the controller cleared DLH8161 to FL350 (see Appendix A), but received no readback from the crew. Over the next eight minutes, the controller attempted to contact DLH8161 on 134.7 MHz nine times, but did not receive a response. DLH8161 was not observed to change altitude and remained at FL330. The most common occurrences of communication failures at Gander ACC are linked to problems with the aircraft.
